City of Douglasville

Historic Preservation Guidelines

Historic Building Guidelines:

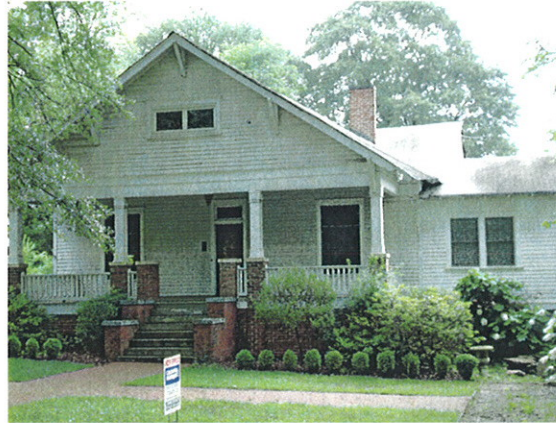
Low pitched gabled roof (occasionally hipped) with wide, unclosed eave overhang; roof rafter usually exposed; decorative (false) beams or braces commonly added under gables; porches, either full- or partial-width, with roof supported by tapered square columns; columns or pedestals frequently extend to ground level (without a break at level of porch floor).

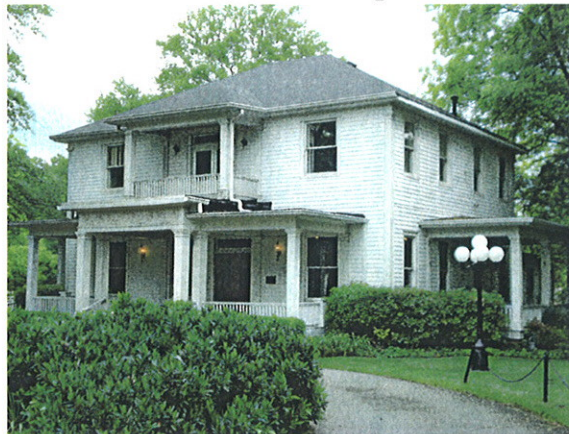
8652 Campbellton Street

Accentuated Front Door, normally with decorative crown (pediment) supported by pilasters, or extended forward and supported by slender columns to form entry porch; doors commonly have overhead fanlights or sidelights; façade normally shows symmetrically balanced windows and center doors; windows with double-hung sashes, usually with multi-pane glazing in one or both sashes.

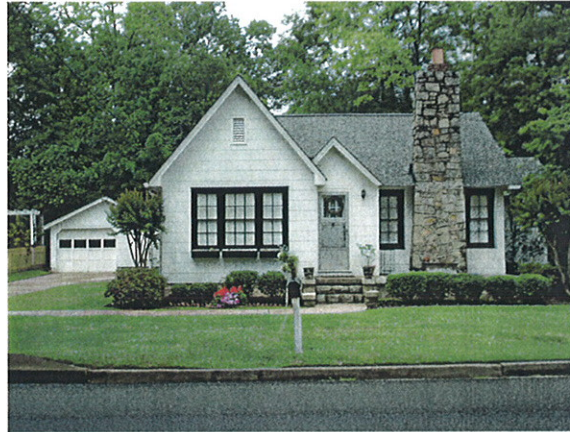
Steeply pitched roof, usually side-gabled (less commonly hipped or front-gabled); façade dominated by one or more prominent cross gables, usually steeply pitched; decorative (i.e. not structural) half-timbering present on about half of examples; tall, narrow windows, usually in multiple groups and with multi-pane glazing; massive chimneys, commonly crowned by decorative chimney pots.

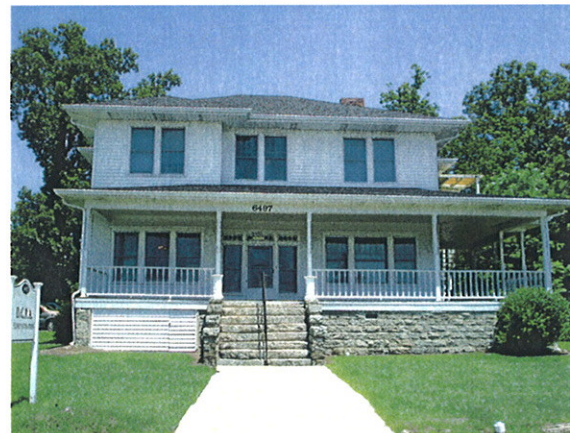
Low pitched roof, usually hipped, with widely overhanging eaves; two stories, with one-story wings or porches; eaves, cornices, and façade detailing emphasizing horizontal lines; often with massive, square porch supports.

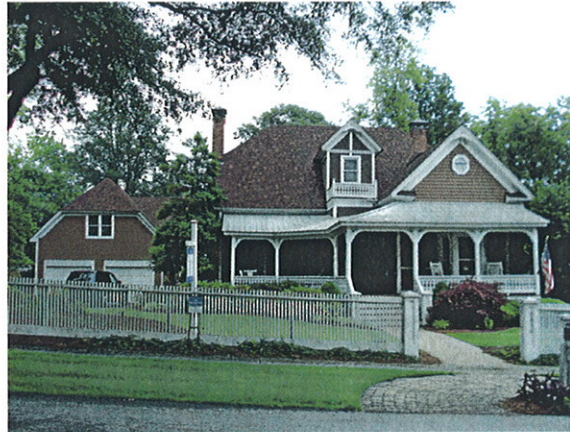
Steeply pitched roof of irregular shape, usually with a dominant front-facing gable; patterned shingles, cutaway bay windows, and other devices are used to avoid a smooth-walled appearance; asymmetrical façade with partial or full-width porch which is usually one story high and extending along one or both side walls.

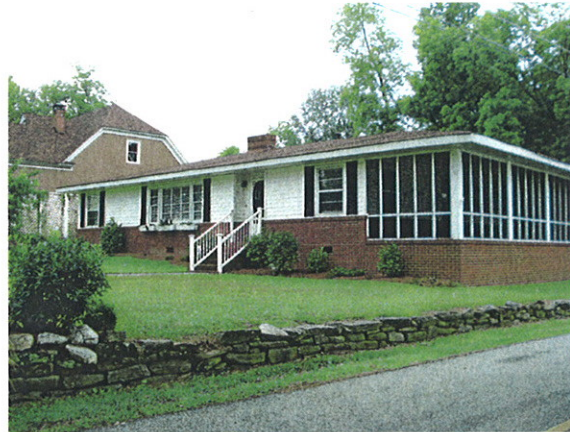
Asymmetrical one story shapes with low-pitched roofs dominate. Three common roof forms are used: the hipped version is probably the most common, followed by the cross-gabled, and finally the side-gabled. There is usually a moderate or wide cave overhang. Partially enclosed patios are common, and contrast with the large front and side porches of most historic homes.

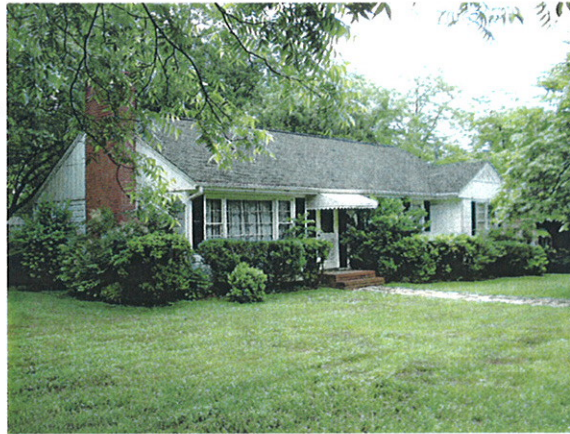
Roof pitches are low or intermediate, rather than steep as in the Tudor Style. Eaves and rake are close, rather than overhanging as in the Ranch Style. Usually, but not always, there is a large chimney and at least one front-facing gable, both echoing Tudor features. They are built of wood, brick, stone, or a mixture of these wall-cladding materials.

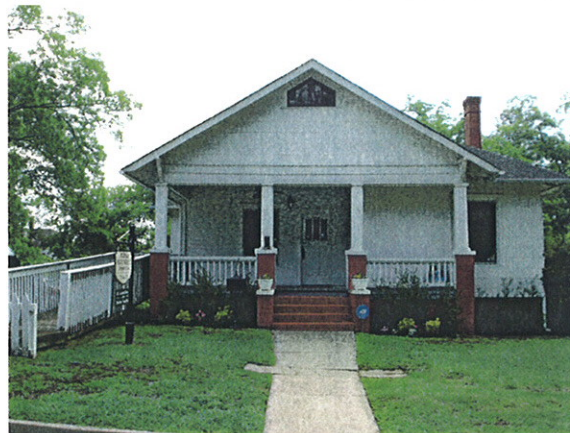
8424 Adair Street

This style has low-pitched roofs with wide eaves and exposed roof rafters and decorative braces. The Craftsman Bungalow has an identifiable porch with square columns normally one or one and a half stories. Many Craftsman Bungalows also have stone chimneys, gabled dormers, and sloping foundations.

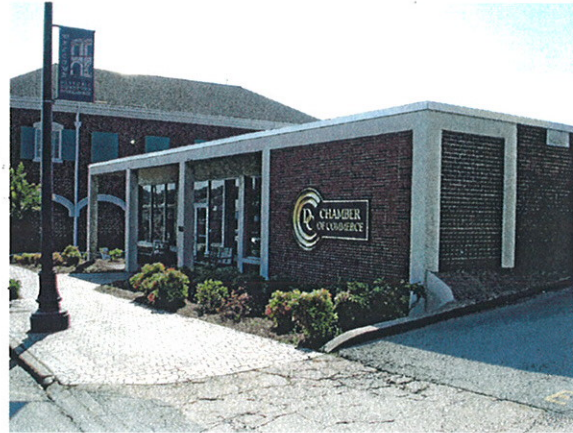
Two distinctive subtypes based on roof shapes; flat or gabled. It features overhanging eaves, frequently with exposed roof beams. Heavy piers may support gables. Various combinations of wood, brick, and stone wall cladding are used and traditional detailing is absent. Both roof shapes are most commonly on-story forms, although two story versions are not infrequent.

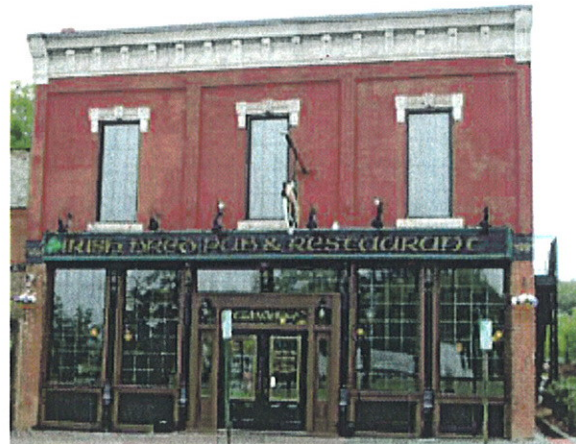
Flat Roof with decorative cornices. Can be one or more stories, with open, glass storefront on first floor. Upper facades often have symmetrical pattern of windows above signboard or decorative cornice separating storefront below. Windows often have multi-pane glazing and decorative hoods. Buildings are often built very close together, and even share adjoining walls.

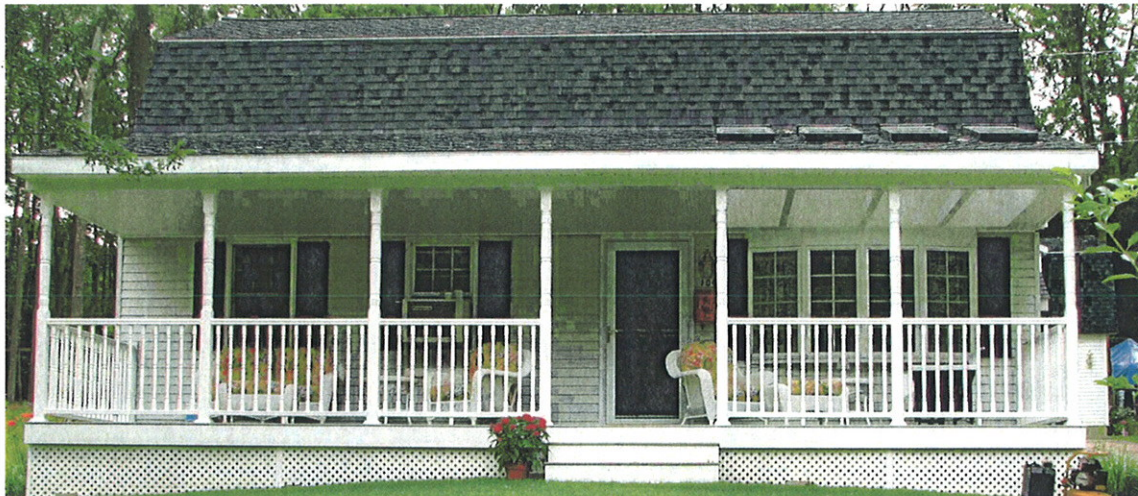
Entrances and porches are a focal point of historic buildings. They can be graceful, inviting, and often an integral part of the design of a historic home. They may stretch across the full width of a house, or wrap around corners. They may be two-story porches, with upper story balconies.

Features such as the porch roof form and shape, the location, type, and number of posts, the location and form of steps and railings, are all significant characteristics that should be preserved. Alterations that detract from the original character and design, such as enclosing a porch, harm the house.

- Identify historic materials such as porch roof shapes and trim, porch floors, railing, columns, banisters, balustrades, floors, fanlights, sidelights, pilasters, entablatures, and stairs for protection.
- Do not remove or radically alter entrances and porches. If a historic entrance has been radically altered or is completely missing, restoration should be based on historical documentation and should be compatible with the historic character of the building, as well as adjacent buildings.
- A replacement porch should not create a false historic appearance by being incompatible with the historic nature of the building or the original entrance.

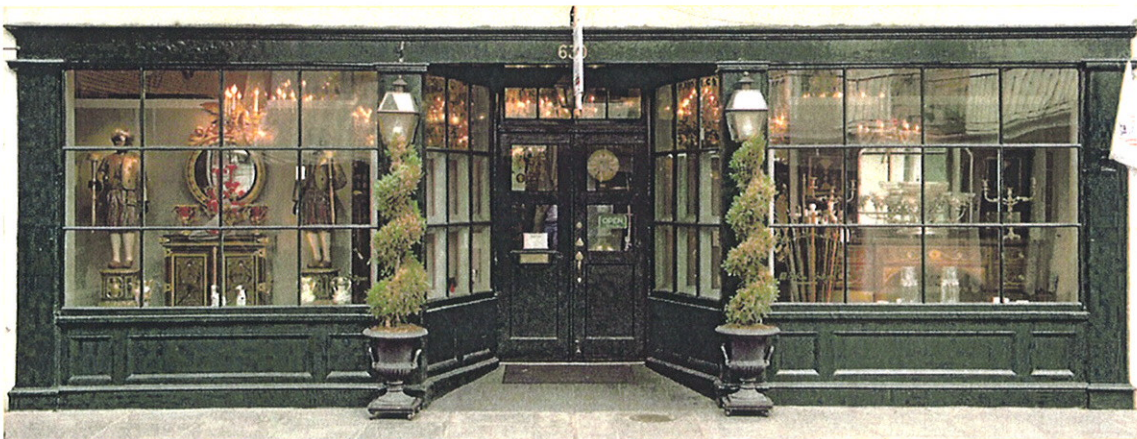
Storefronts are the face of historic commercial buildings, and are extremely important in defining their historic character. Douglasville's historic commercial buildings typically have storefronts with recessed entrances, and thinly framed windows. Cornices or awnings are used to separate the lower and upper stories.

Historic storefronts should be repaired rather than covered. Storefronts can consist of a variety of materials, which should be maintained or replaced with new materials that remain consistent in design, composition, texture, and other visual qualities.

- Components of the original façade should be incorporated into the rehabilitation and renovation designs.
- The building façade should not be obscured by metal or plastic siding or panels.
- Original building materials should not be obscured.
- Facade details should not be covered over, removed, or obscured by painting.
- The shape of the original storefront openings including windows, doors, and transoms should not be altered. If doors and windows must be blocked, the original shape should be maintained.
- Respect the storefront's original architecture, and repair or replace building components where possible.
- Do not attempt to make the storefront older than it really is by using an inappropriate historical theme.
- A storefront should be designed to fit inside the original opening and not extend beyond it.

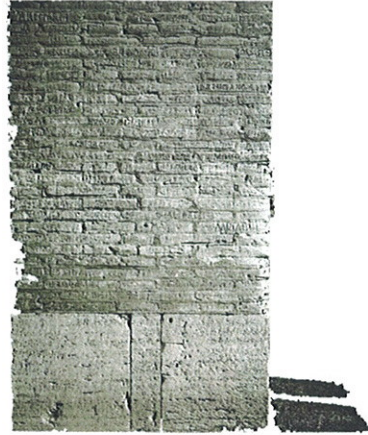
Foundations are typically one of the most neglected character-defining features of historic buildings. Historic homes are typically built on piers, which have almost invariably been infilled. Such infill should not cover or detract from the historic nature of foundation piers. Also, some accommodation should be made for ventilation and access to crawl spaces.

Infill of historic foundations should be recessed slightly behind the piers, so that the historic form of the foundation is visible.

If infill material does not match foundation material, infill may be painted a dark color to resemble a void.

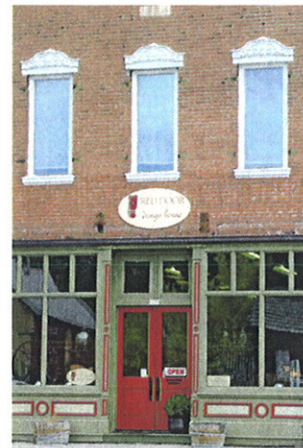
The upper facades of historic commercial buildings help to define not only the unique character of individual buildings, but also the historic feel of Douglasville's downtown. While recognition of each building's unique character is important, there are common elements to historic commercial buildings which are important to maintain.

Cornices, signboards, and upper story windows are or were elements found in nearly all historic commercial buildings in downtown Douglasville. It is important to preserve such character defining elements, and not cover them over with awnings, newer smaller windows, or other elements that detract from the historic character of downtown.

- Brick corbelling and stamped metal, or wooden cornices should be maintained and preserved.
- Any historic architectural details should be repaired, maintained, or replaced with a duplicate of the original. Inappropriate “theme” decoration should be avoided.

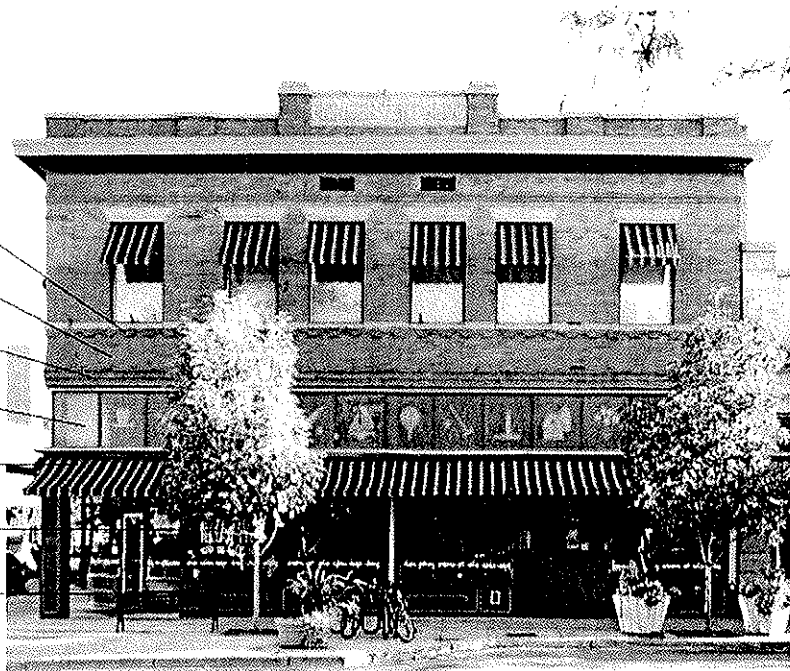
Decorative Pattern
Sign Area
Bulkhead
Transom Windows
Awnings
Display Windows
Base

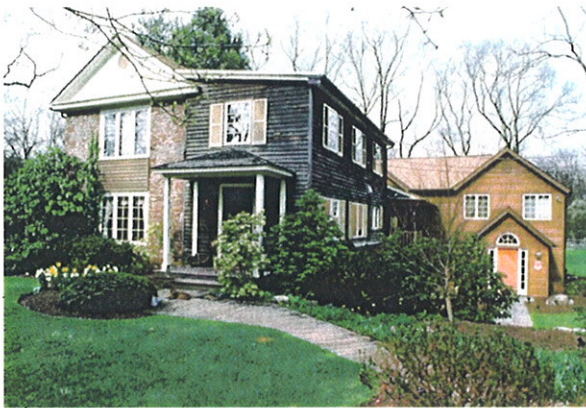
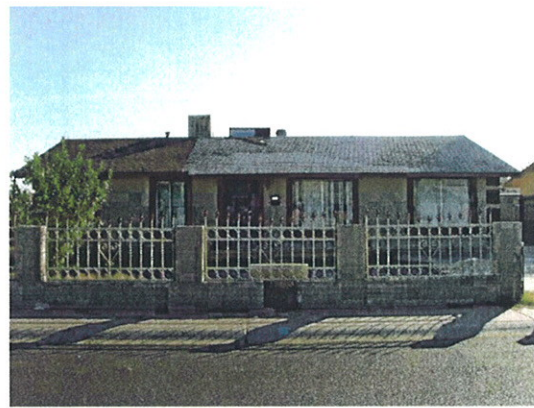
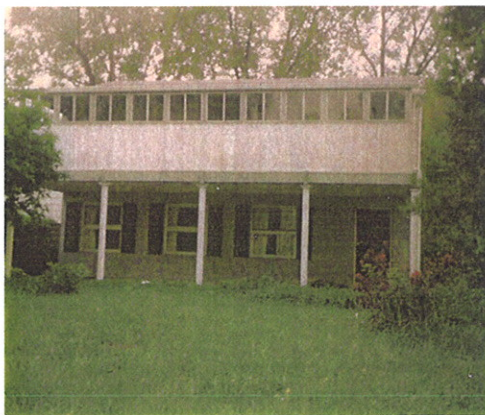
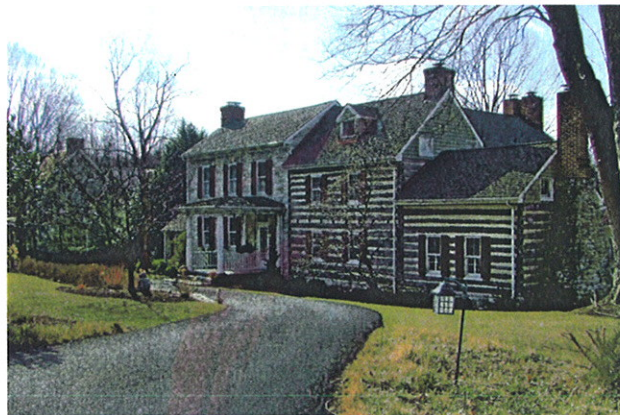
Unsympathetic Additions

Additions greatly effect the aesthetic of any house, but even a nice addition can easily destroy historic character if not properly planned and considered.

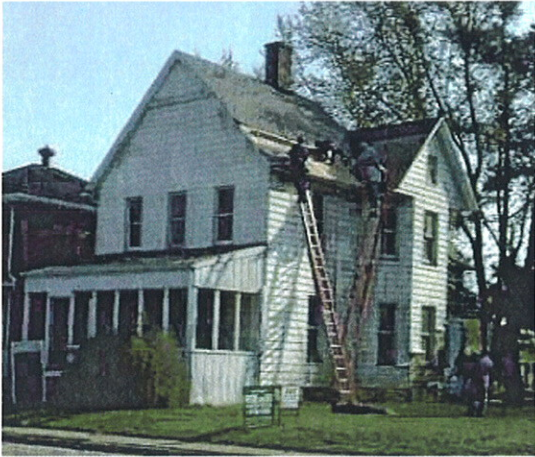
Historic house with artificial siding

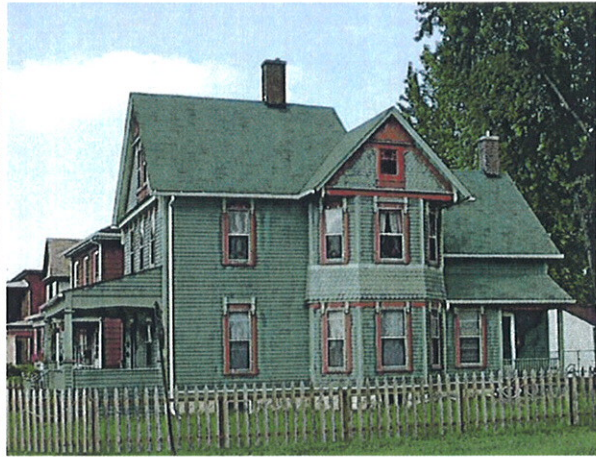
House restored to original siding

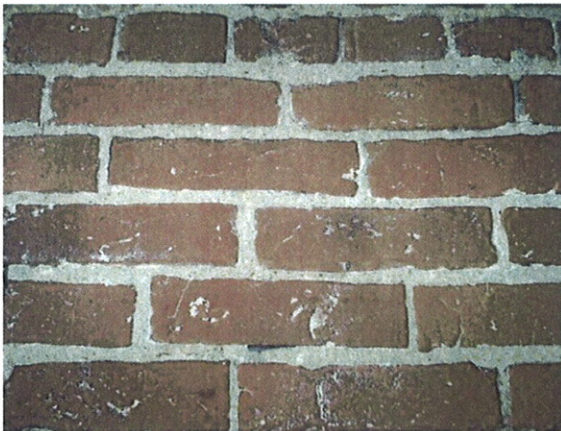
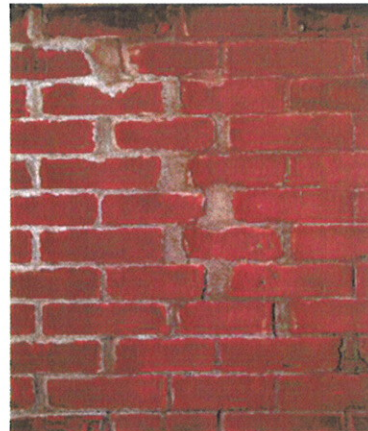
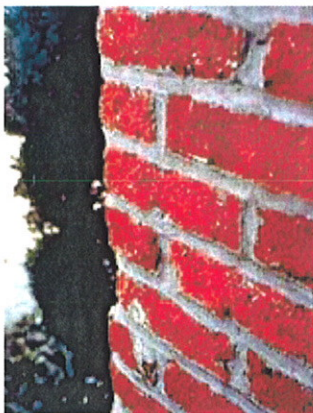
Sandblasting/Poor Pointing

Brick and stone can create a beautiful historic façade, however without proper maintenance the aesthetic can easily be ruined.

- Evaluate the overall condition of masonry to determine if more than normal protection and maintenance is required.
- Never sandblast brick or stone surfaces using dry or wet grit or other abrasives including: walnut casings, seashells, or glass pellets. These methods of cleaning permanently destroy the material, may harm the mortar, and speed up deterioration.
- Historic masonry should not be coated with new paint (unless masonry is historically painted), stucco, vapor permeable water repellent, or other non-historic coatings. If masonry is historically painted and paint is removed, it should be repainted to retain its historic integrity.
- Historic stucco that has been damaged should be removed and patched with new stucco that matches the original in strength, composition, appearance, and texture.

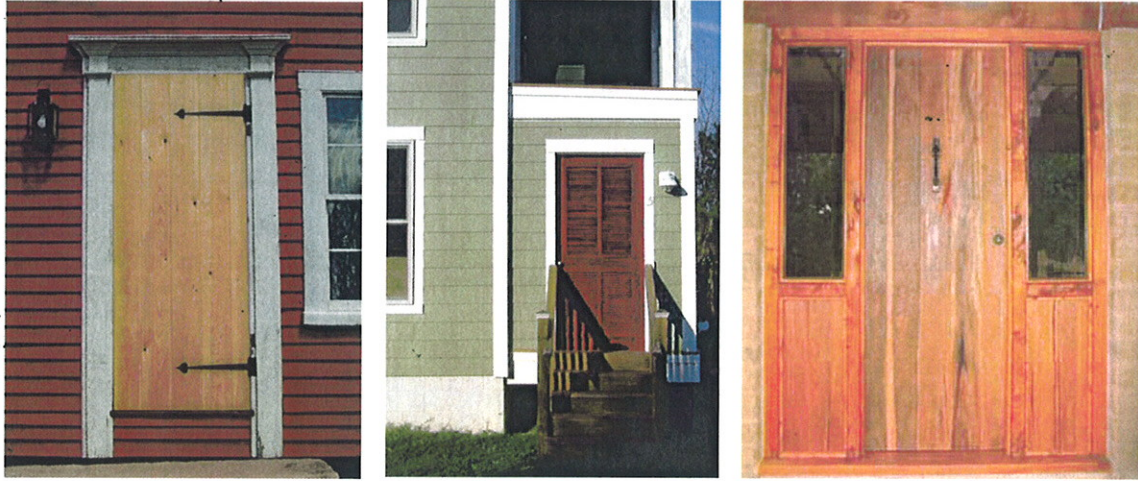
Inappropriate Doors

Doors and windows are the most worked on and changed feature of a historic home. It is important to remember their importance in maintaining historic integrity.

- A replacement door should not create a false historic appearance by being incompatible with the historic nature of the building or the original entrance or door.
- If a storm door is to be used, it should have a color clad frame and a full view glass, or be designed to respect the historic nature of the original entry door.
- Historic window and door locations, numbers, sizes, and glazing patterns (of windows) should not be changed.
- Historic trim should not be obscured.
- New shutters should be sized to cover windows and should be fastened to the window casing, not the siding.
- Entrance doors to commercial buildings were historically made of wood, however aluminum doors that have wide stiles and a dark anodized enamel finish so as to appear wooden are acceptable.
- Wooden doors and frames should be maintained whenever possible.

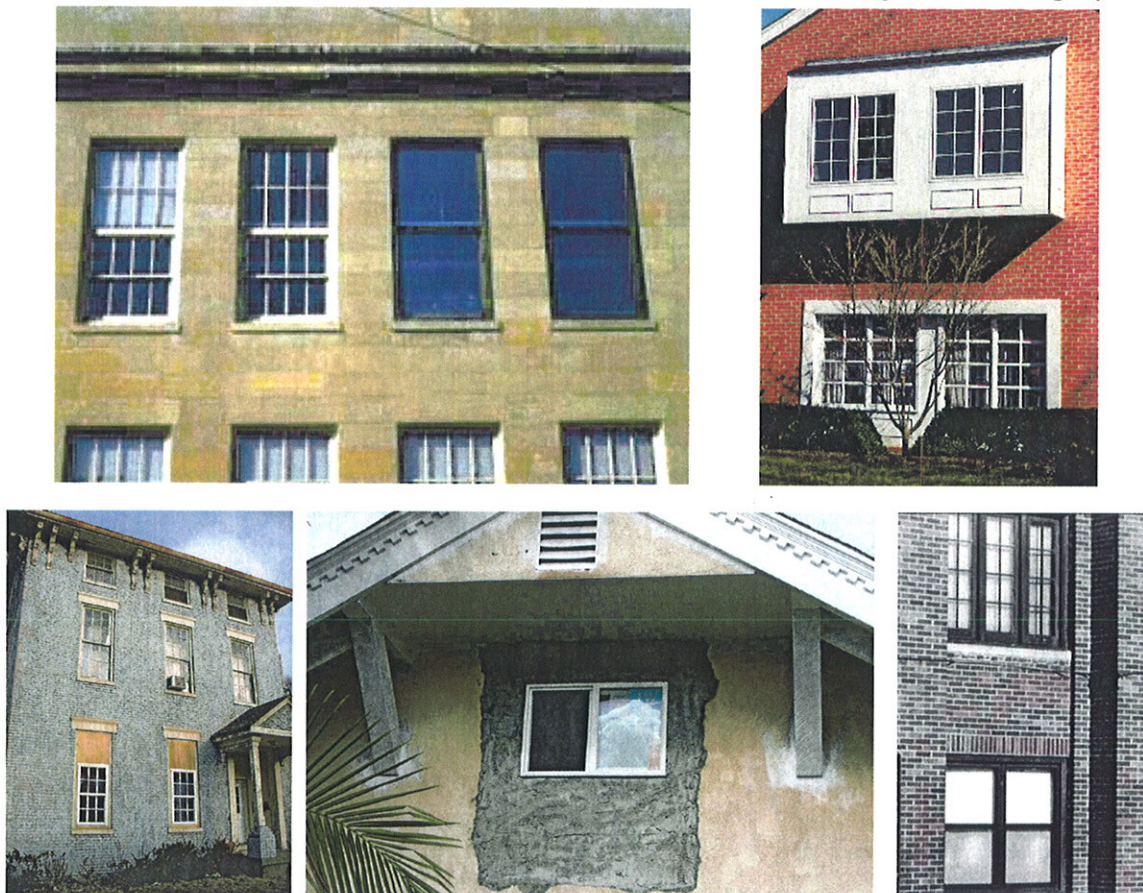
Inappropriate Windows

Windows and doors are the most worked on and changed feature of a historic building. It is important to remember their importance in maintaining historic integrity.

- Windows and window openings should be preserved and maintained in their original appearance. If replacement windows are necessary, the original pattern and shape of the window should be duplicated. Wooden sash is preferred, but backed enamel aluminum is acceptable.

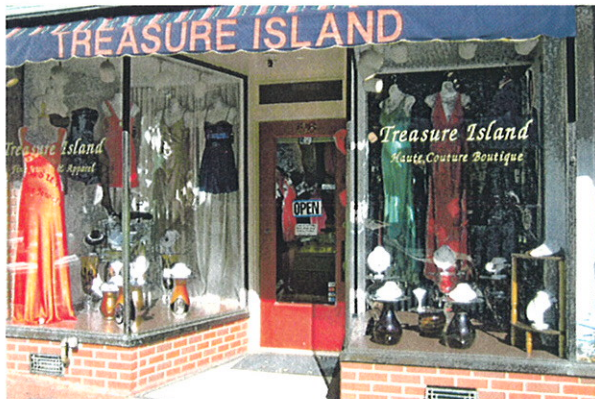
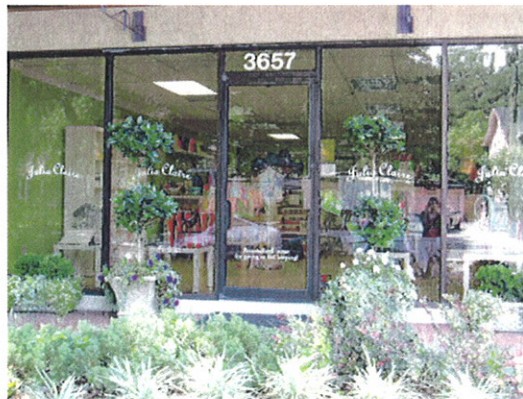
Both of these Storefronts look nice, but do not maintain a historic character.

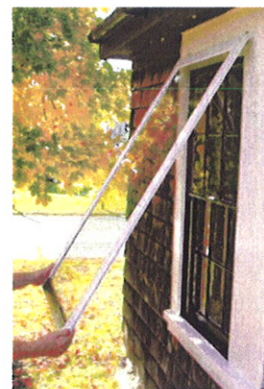
The storm window on the right does not detract from the

historic window behind it.

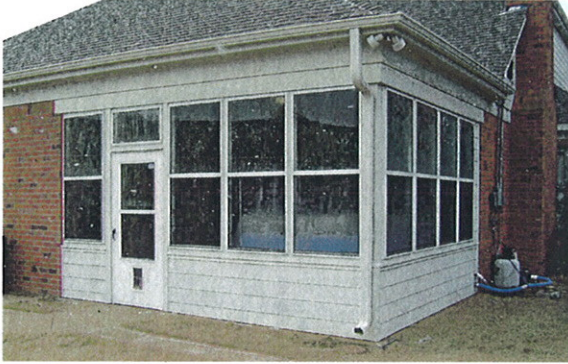
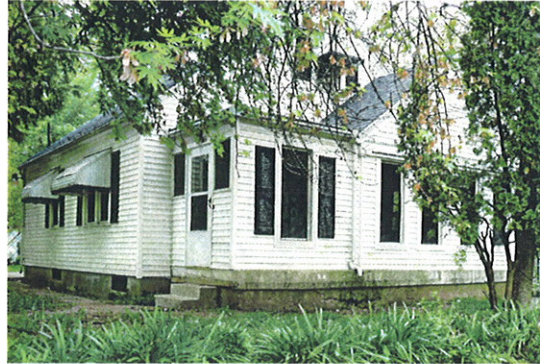
Inappropriate Porch Treatments

Porches are the face of a historic house, and improper treatment or covering of a porch can greatly damage the historic character.

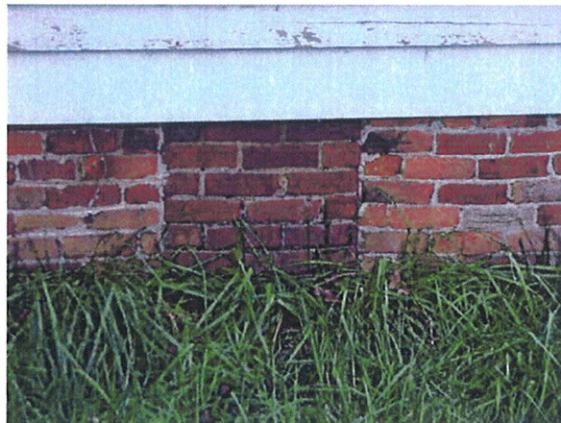
Inappropriate Foundation Treatments

While often overlooked, a foundation is an important part of creating historic character.

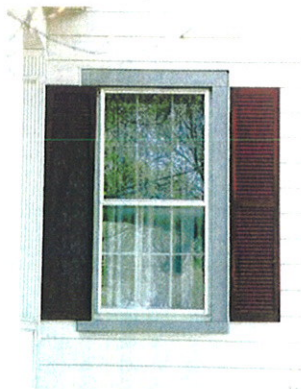
Shutters should be affixed to the window frame, and be allowed to swing freely. Shutters such as those on the right are not sized to fit the window, and are attached to the outside of the frame, creating

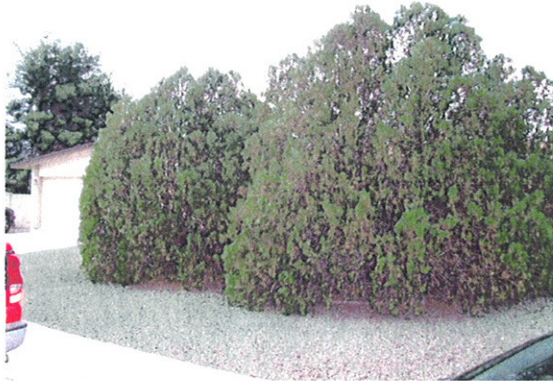
House with inappropriate bushes

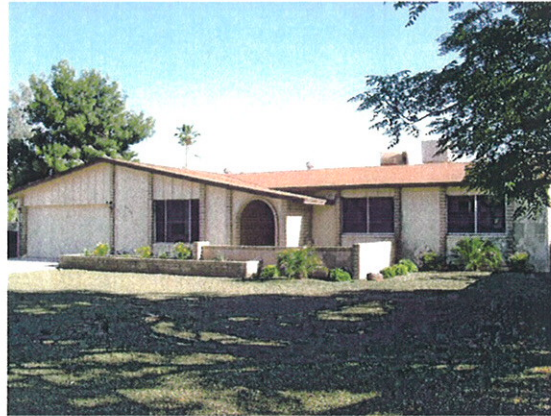
Same house without bushes

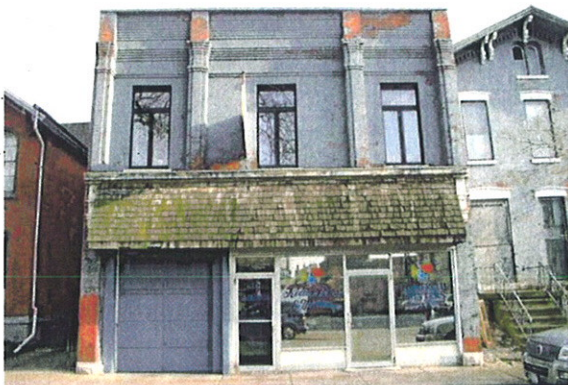
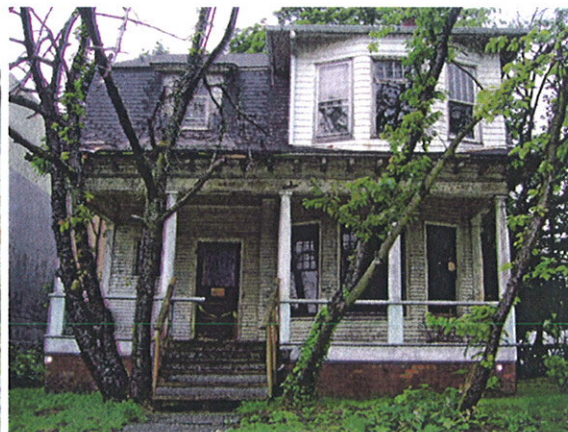
Neglect/Poor Maintenance Practices:

Improper maintenance and neglect is harmful not only to the individual property, but also to the neighborhood and district as a whole. Because property owners are legally responsible for providing ordinary maintenance and repair, neglect should be avoided.

The Douglasville Building Inspection Department is legally required by the Southern Standard housing code to inspect properties to determine if they are being allowed to deteriorate through neglect. Neglect includes conditions such as the deterioration of the building's structural system or exterior architectural features as well as broken windows, doors, and other openings which allow entry of vermin and the elements.
